Feb 27th, 2025
43 East 30th Street, Holland, MI 49423

Home Inspection Report

David Atkins / Atkins Home Inspections

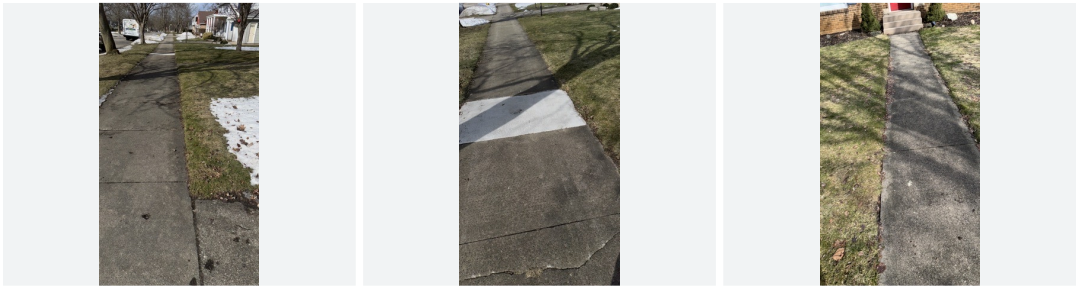
1.2 WALKS

Walks in good

During time of inspection report sidewalks were in good shape with cracks and heaving repaired.

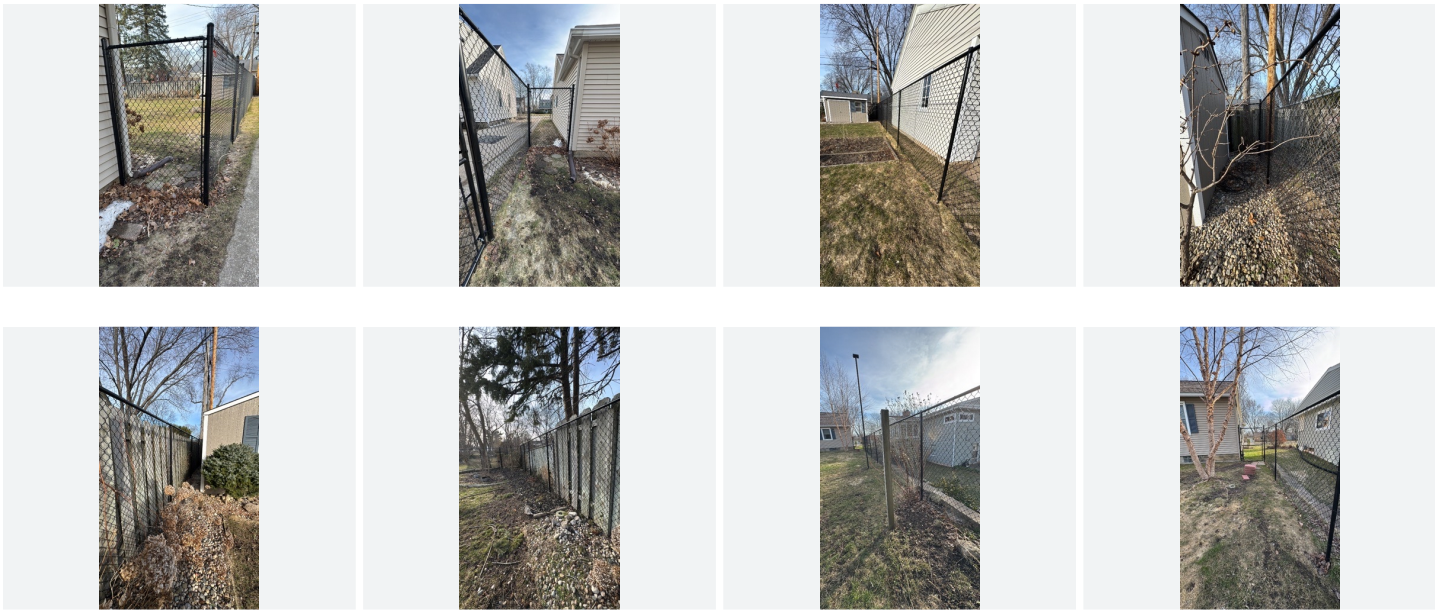
1.5 FENCES/RETAINING WALLS

Fence
brand new and perfect working condition at time of inspection.

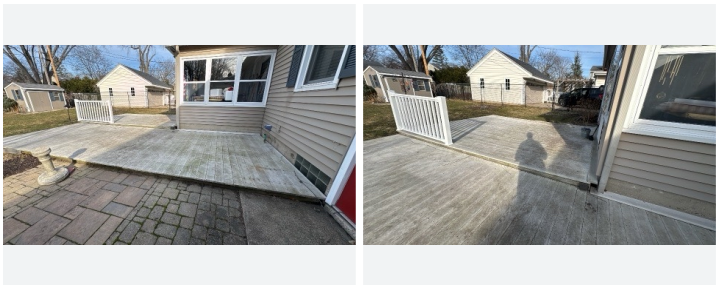
1.6 DECK/BALCONY

Deck built on grade. Unable to inspect the underside.

Missing handrail(s)

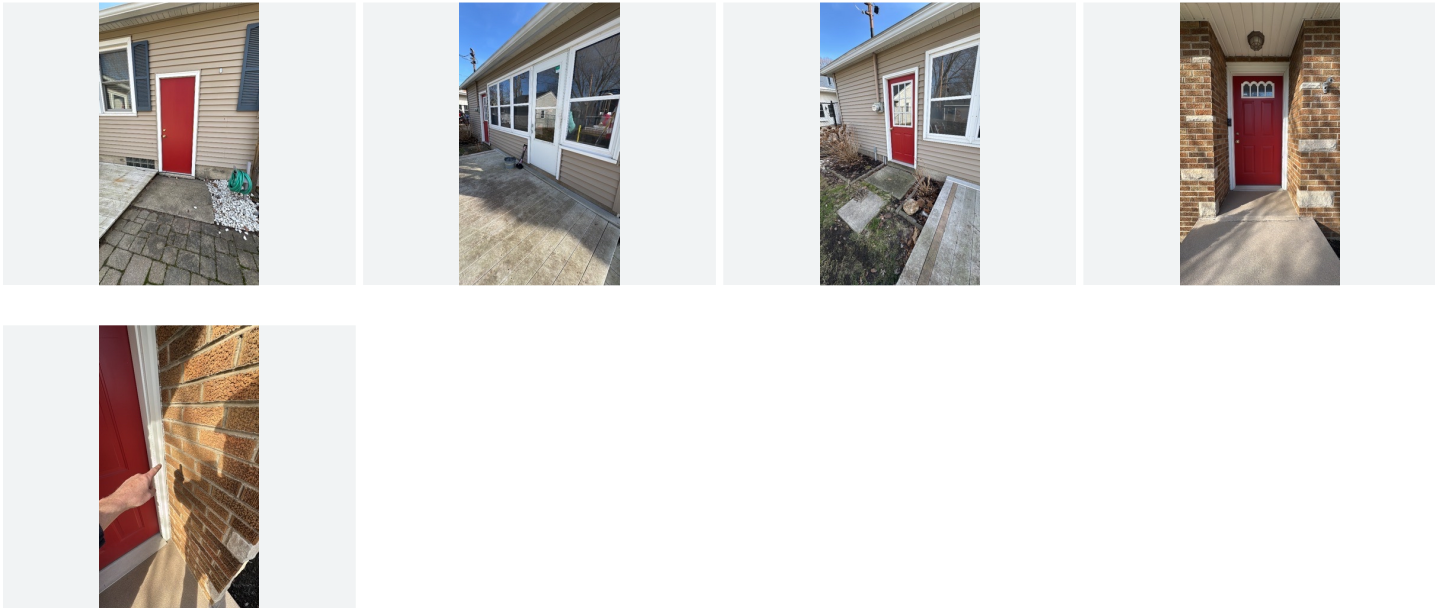
2.4 EXTERIOR DOORS

Front door

At time of inspection noticed that caulking around front door needs to be updated and taken care of. Water could leak in.

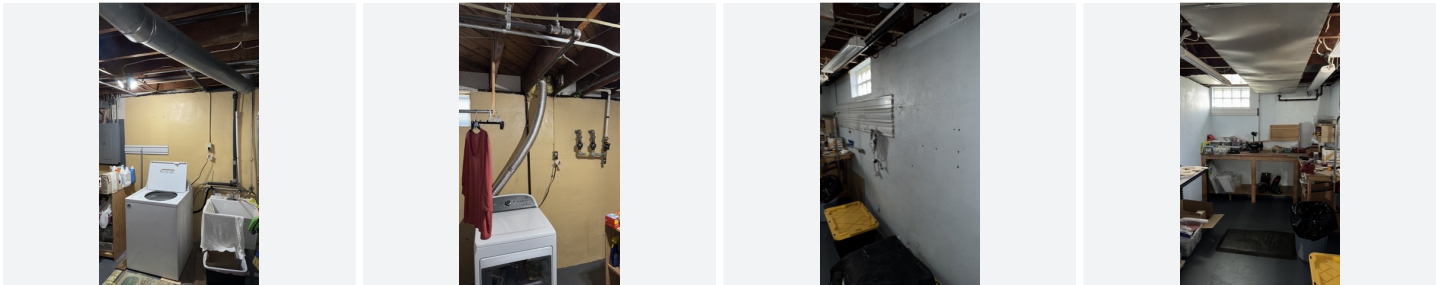
5.2 FOUNDATION

The foundation areas were not fully accessible and portions were not inspected

At time of inspection visible foundation appears to be in great shape. All cracks and leaks have been dealt with and sealed.

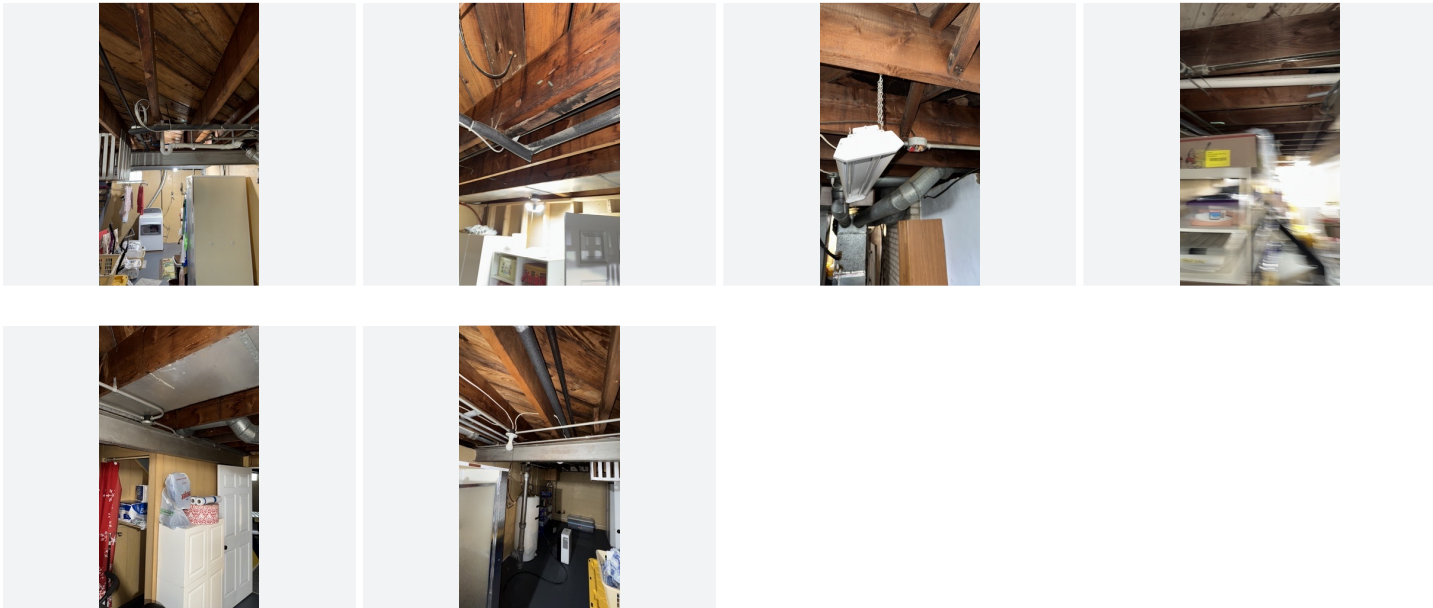
5.3 BEAMS

Beam in basement
Recommend that a beam that has been patched together in basement be inspected by a structural engineer.

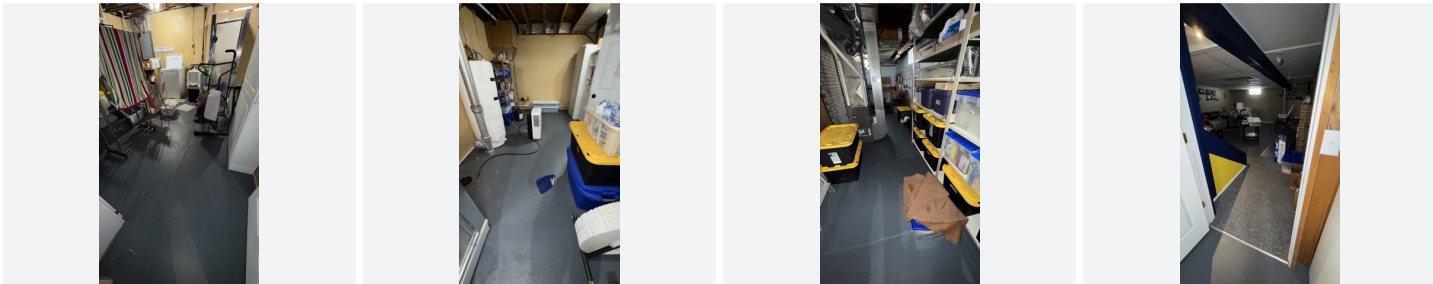
5.4 FLOOR/SLAB

Partial slab covered
Floor covering(s) prevents view of slab. Half of the basement is covered with carpet can't view the slab underneath it. Inspected the other half and it appears to be in good shape during inspection no visible cracks and foundation or slab.

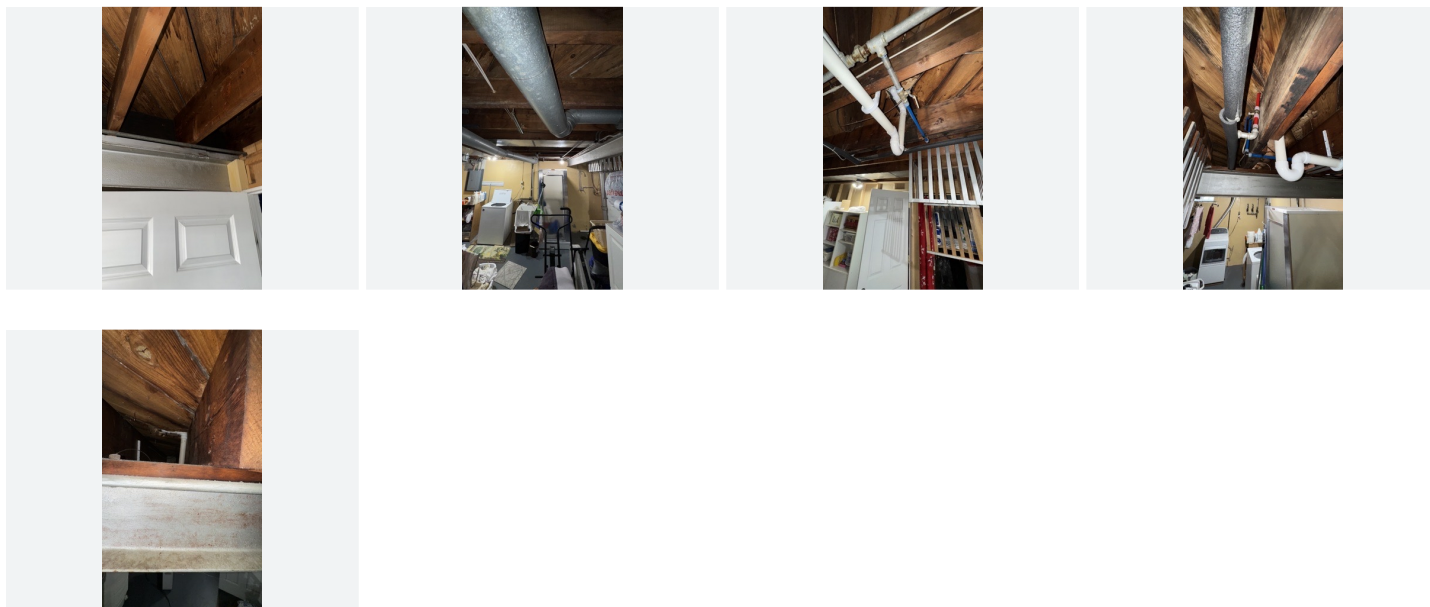
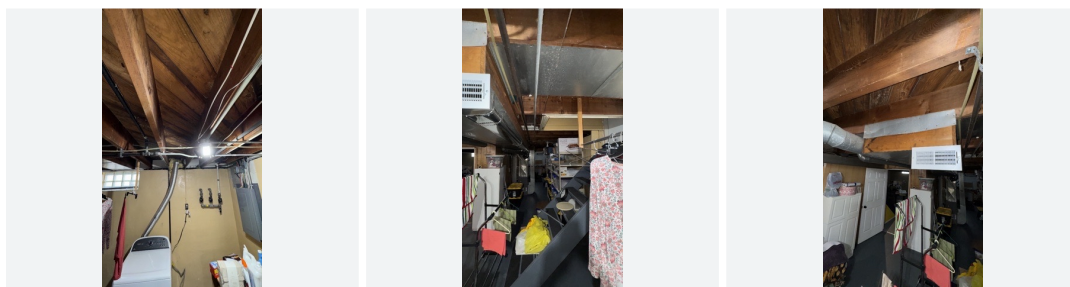
5.5 JOISTS/TRUSSES

Finishes block visual inspection of joist(s)/truss(es)

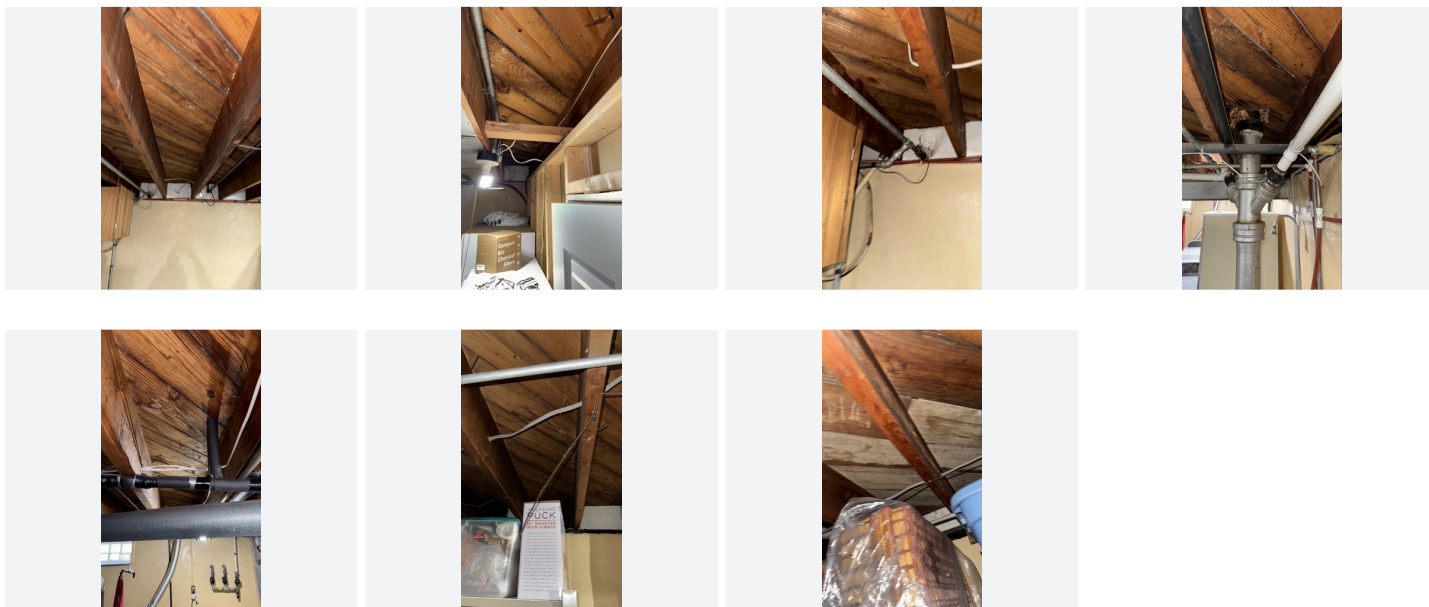
5.7 SUBFLOOR

Inspected accessible subfloor from basement and noticed that subfloor is in good shape is a one by six pine slat floor on a 45° angle underneath hardwood floors.

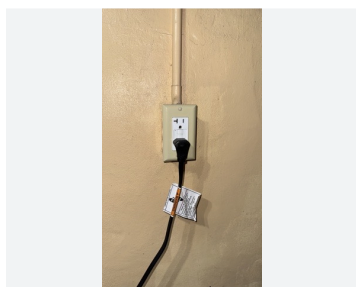
6.4 GFCI/AFCI

GFCI is present in basement bathroom and garage. All tested well during inspection.

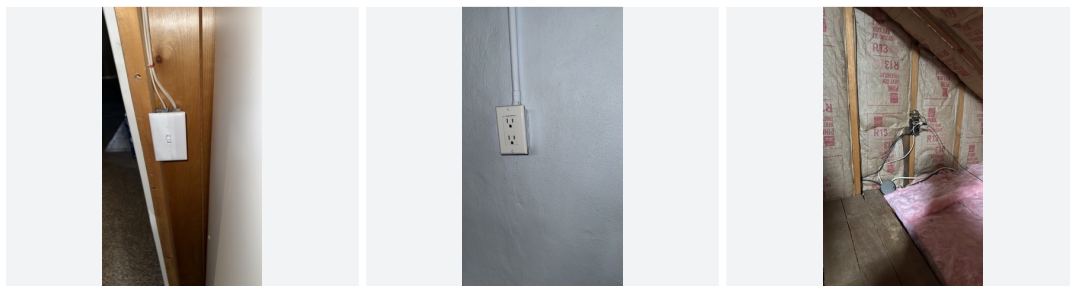
6.5 BRANCH CIRCUITS

Missing covers

Cover(s) missing from box(es) Need replacing.

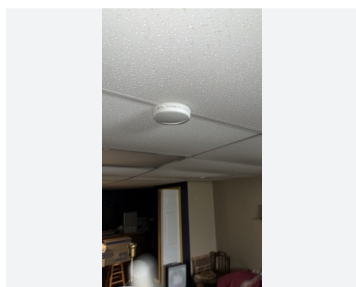
6.6 SMOKE DETECTORS

during time of inspection, Smoke detectors function well during test

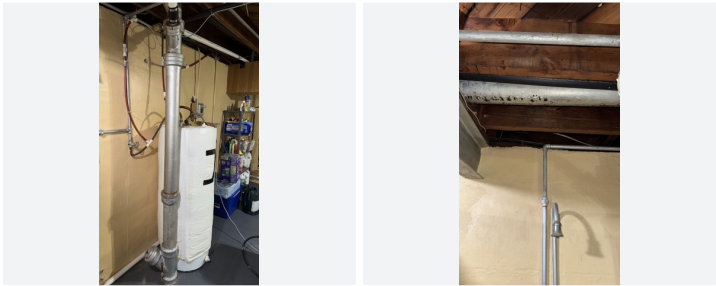
7.4 DRAIN PIPES

Finishes block visual inspection of drain/sewer lines

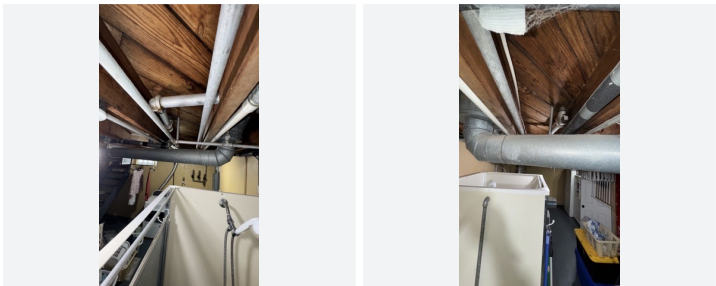
7.5 VENT PIPES

At time of inspection vent pipes to appear to be working as they should.

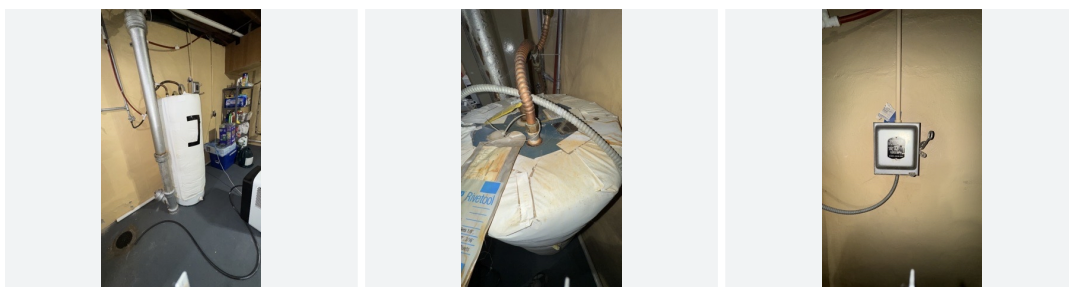
7.7 WATER HEATER

At time of inspection, TBR valve could not be tested because drain pipe was not attached that would drain to the floor drain

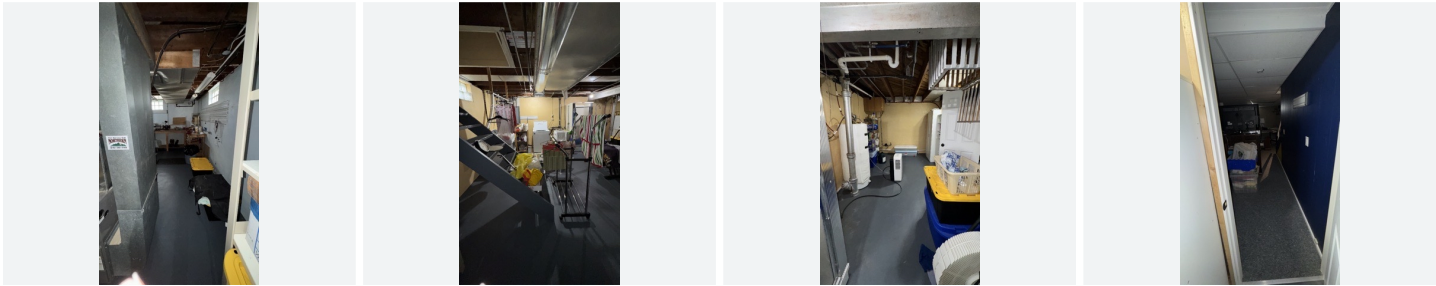
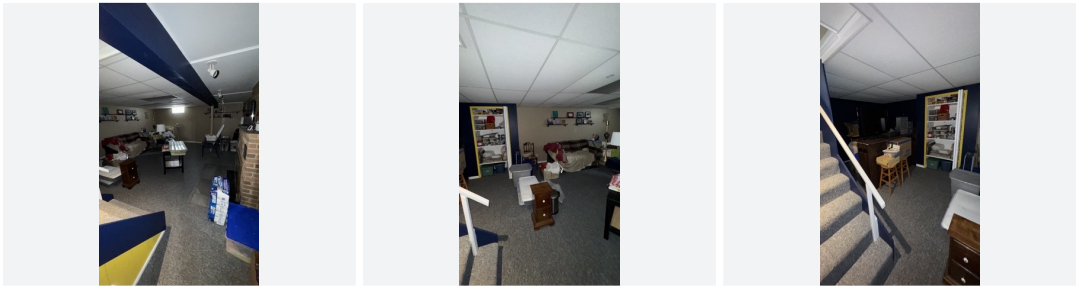
9.1 TYPE

Finishes block a complete visual inspection of insulation

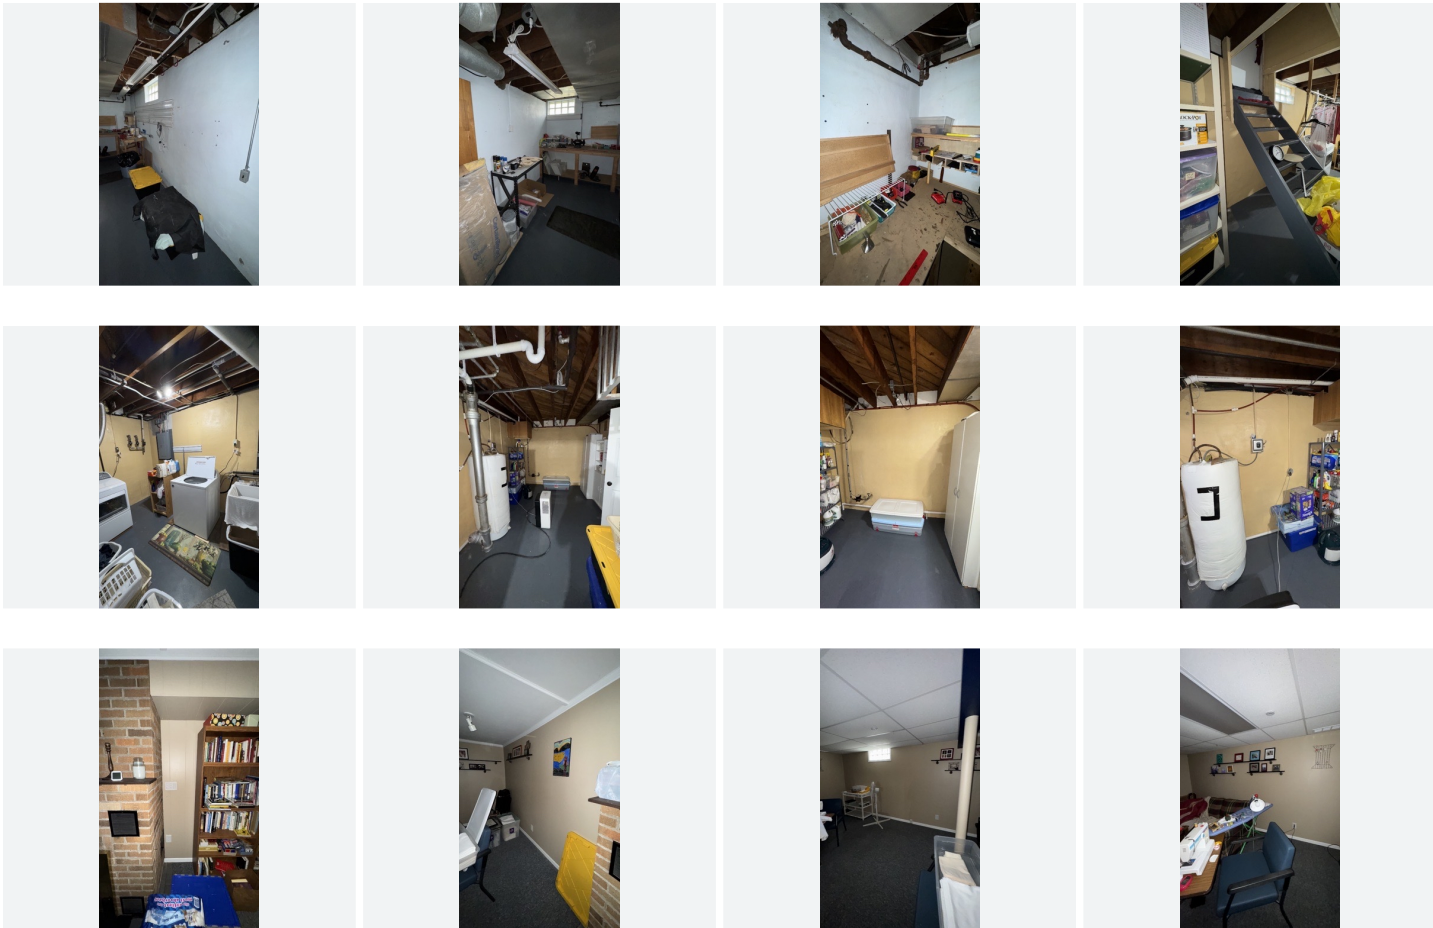
9.3 WALLS

Basement walls all appear to be in good shape. Unfinished parts of basement walls are painted and cracks are sealed drywall and paneling areas as well are in good shape at time of inspection

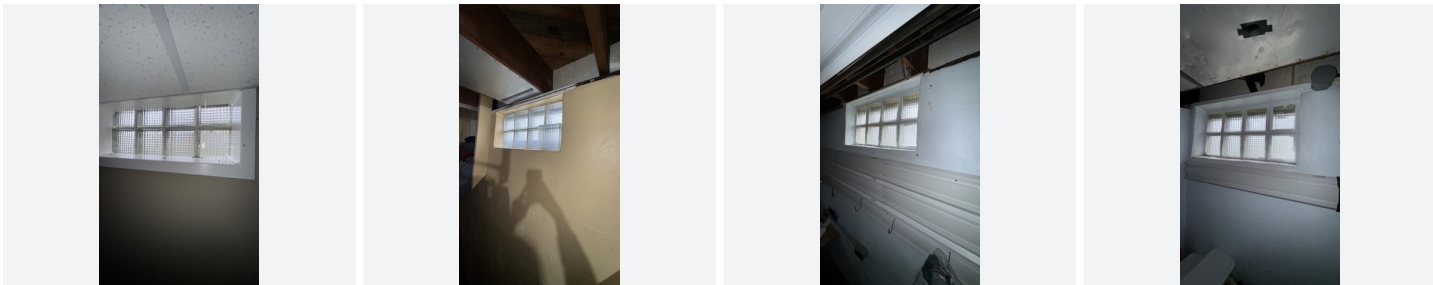
9.4 WINDOWS

Will not open

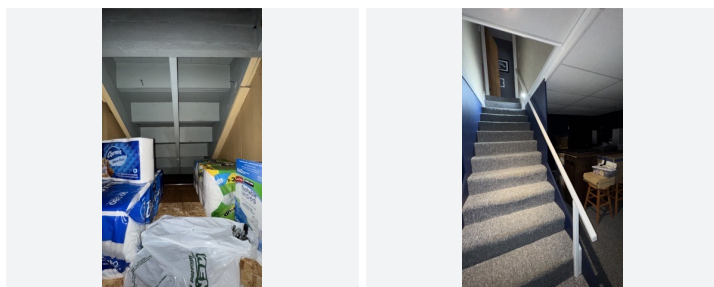
9.8 BASEMENT STAIRS/RAILINGS

Basement handrail at bottom of stairs seems to be not properly attached and has a fair amount of flex at the main post that is to be secured into the stairs. Recommend that fasteners and a better type of post be installed to secure the rail.

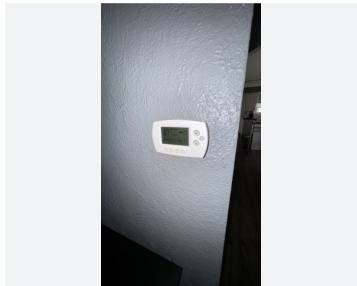
10.1 THERMOSTAT(S)

Secure thermostat to wall

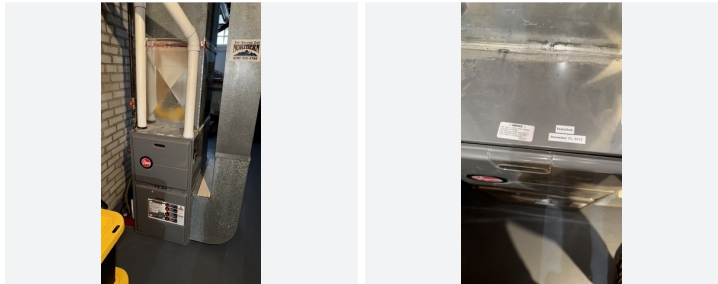
10.2 HEATING SYSTEM

At time of inspection, the filter door was missing and a piece of thin plywood was covering the filter trap door. Recommend that a filter door to be attached to keep the airflow, consistent and controlled.

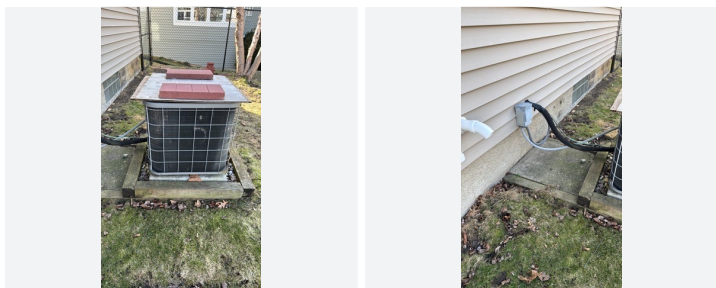
10.5 COOLING SYSTEM

Unable to test due to season/exterior temperature

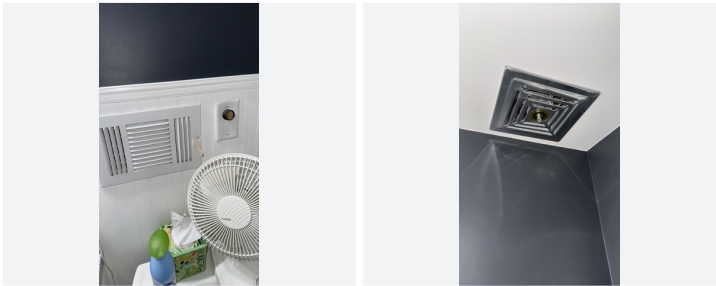
11.7 VENTILATION

Fan is noisy

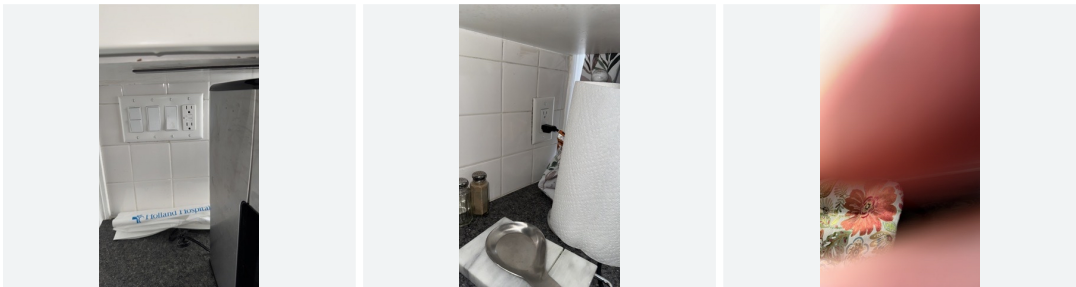
12.1 ELECTRICAL

All kitchen electrical appear to be working as should be during inspection. Tested all outlets all switch switches and ran microwave.

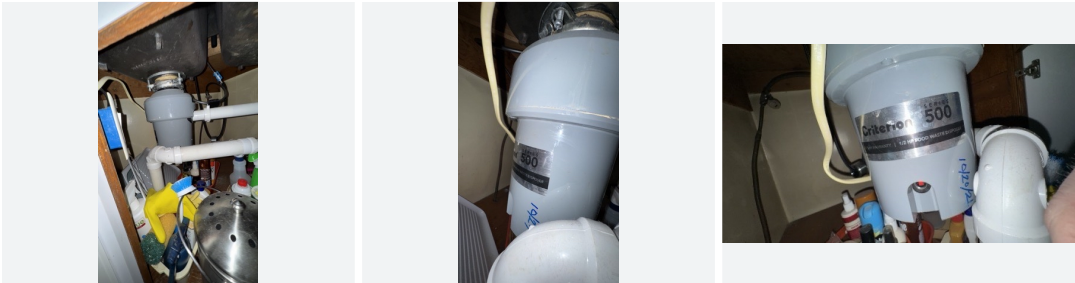
12.6 DISPOSAL

Appeared functional at the time of the inspection

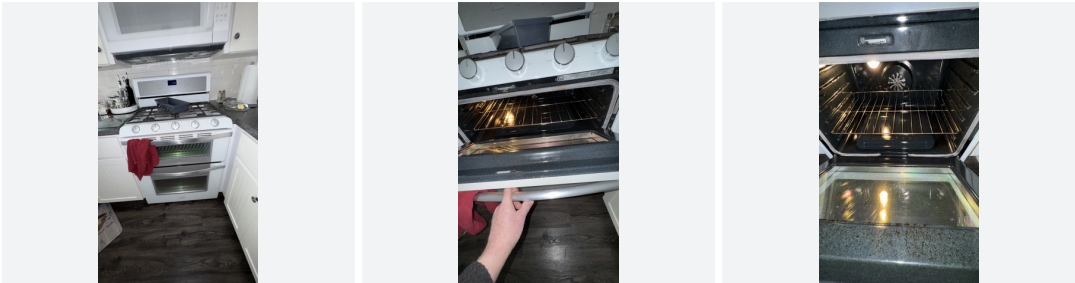
12.7 RANGE/OVEN

Appeared functional at the time of the inspection

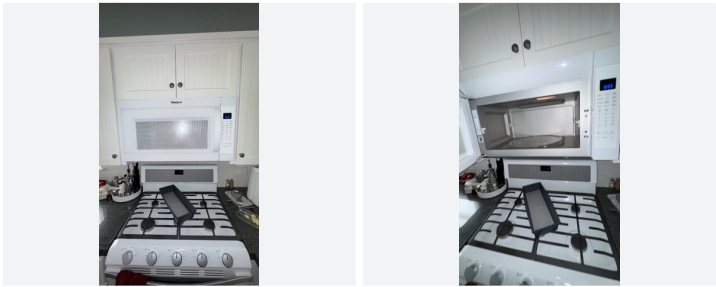
12.8 MICROWAVE

Appeared functional at the time of the inspection

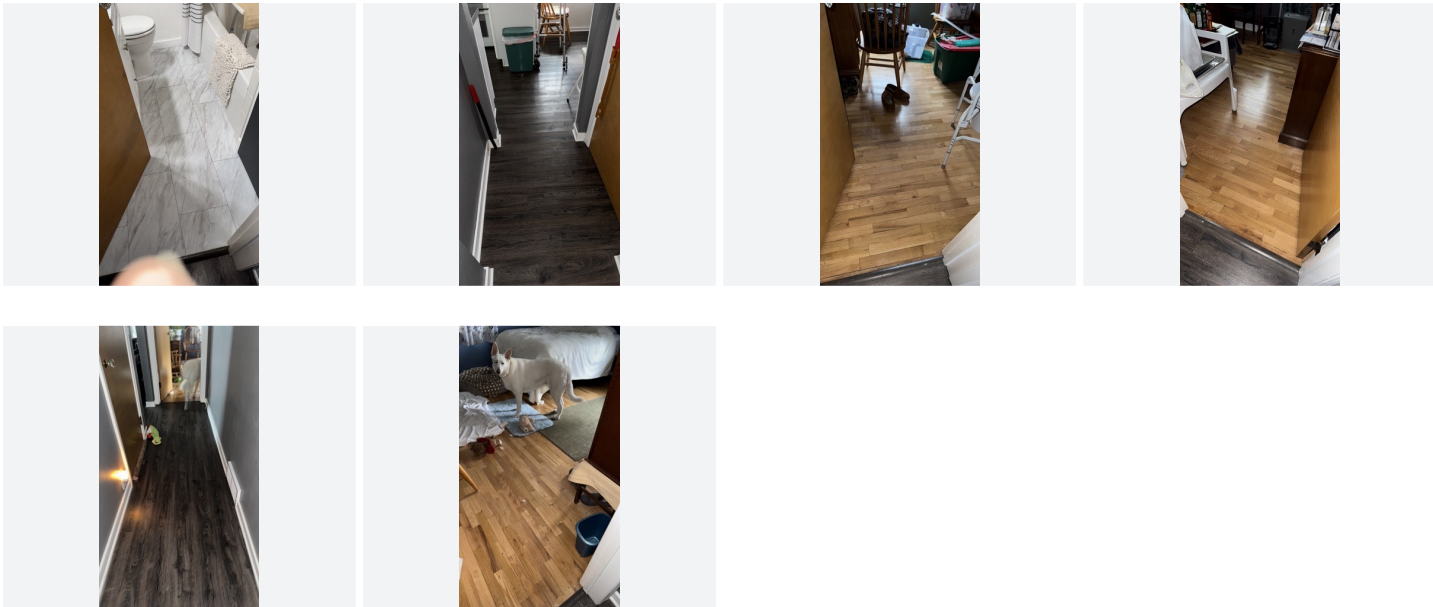
13.4 FLOOR

Uneven floor typical for a home of this age
